4. TITLE AND SUBTITLE
The Use of Electrochemistry and Ellipsometry for Identifying and Evaluating Corrosion on Aircraft.

Chester M. Dacres, Guy D. Davis,
Lorrie A. Krebs, Mark B. Shook

DACCO SCI, INC.
10260 Old Columbia Road
Columbia, MD 21046

**THE USE OF ELECTROCHEMISTRY
AND ELLIPSOMETRY FOR IDENTIFYING AND EVALUATING
CORROSION ON AIRCRAFT**

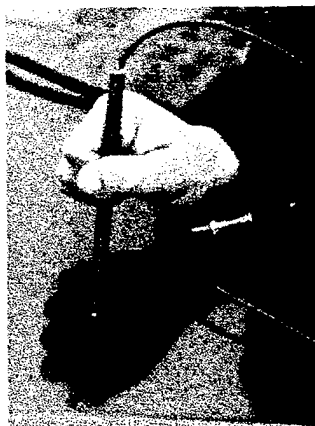
Figure 3. *Hand held in-situ corrosion sensor.*

Two versions of the *in-situ* sensor have been developed: a permanently attached sensor and a portable hand-held sensor. The former is suitable for corrosion inspection in inaccessible areas or for automatic or semi-automatic inspection of a particular area. A laboratory test specimen with an attached sensor is shown in Figure 2. The hand-held sensor is suitable for spot inspection where a permanent sensor is not desired or had not been previously placed. Figure 3 shows a prototype in use.

The final prototype sensor (Figure 3) was designed to provide easier use than the upscale sensor. It had a much smaller diameter and was several inches longer. A long shielded lead wire was permanently attached. This allowed the connection to the Gamry to be made at a distance from the sensor, thus eliminating the wire congestion around the sensor. The connection to the Gamry was made with a BNC connector. The sensor was intended to be used like a pen-type probe. The final sensor was much easier to use and provided results similar to both the first prototype sensor and the upscale sensor (Figure 27).

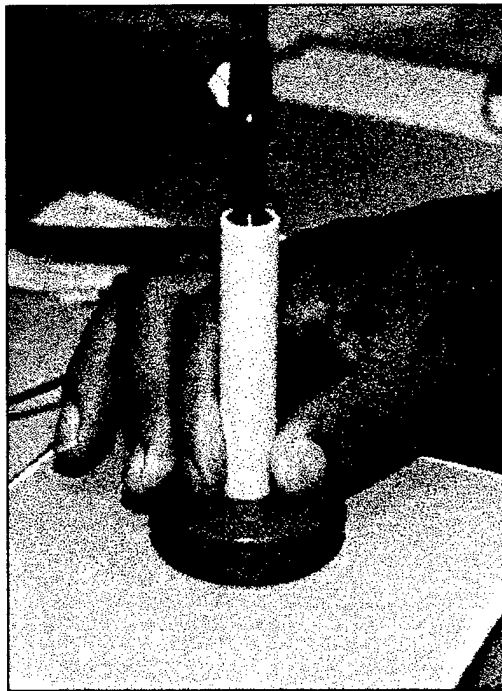
Figure 25. *Upscale Prototype Sensor.*

The upscale prototype hand-held sensor was fabricated with the sensing component encased in a PVC shell (Figure 25). The circular base of the sensor was also constructed of PVC and was sized to allow the sensor to be held by the fingertips or in a manner similar to a joystick.

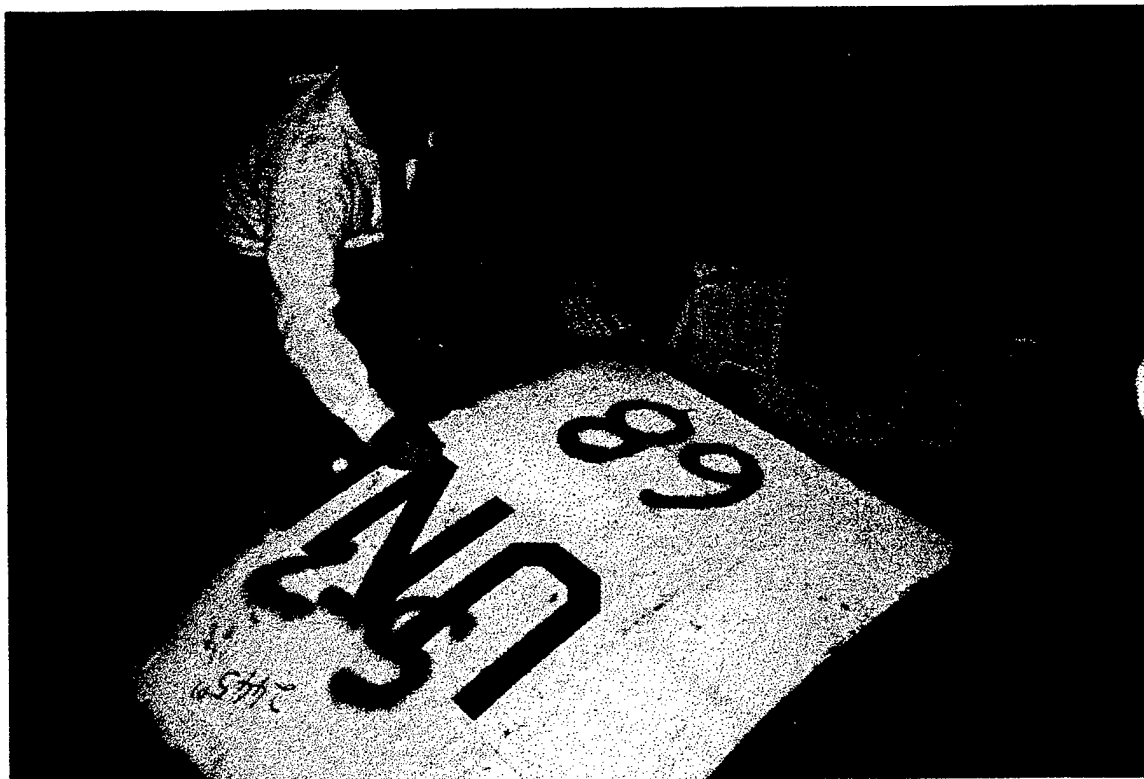
Figure 31. *Photograph of Testing on C130 Fuselage.*
